SHFV mechanical seals for vertical pumps

Darlington Nuclear Generating Station is located 70 km east of Toronto/Canada. The four unit station is the newest generating station of Ontario Power, performs a total output of 3,512 MW and provides about 20 % of Ontario's electricity needs, enough to serve a city of two million people.

16 Sulzer single-stage vertical reheater drain pumps type BJ3X4X11 model TXR are installed. The second stage reheater drains system drains the condensate and vents any uncondensed steam from the second stage reheater tube bundles and directs these to the steam generator and the HP heater.

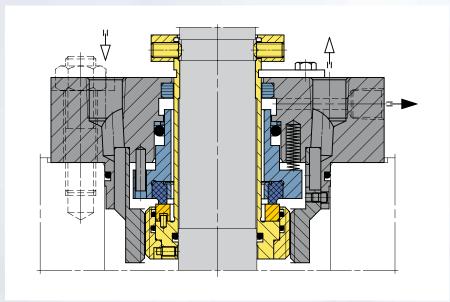
SHFV1 seal design

EagleBurgmann designed a new sealing system, the SHFV1/42-E1 with API plan 23. This system had to pass through a performance test at the EagleBurgmann facilities at Wolfratshausen, Germany. The test was arranged with the original equipment and operation conditions of Darlington Nuclear. All tests have been performed successfully without any problems.

Seal features

- Stationary multiple springs and integrated pumping screw
- Pressure stabilized reinforced carbon seal face with hardened metal support ring
- Material combination for optimal heat transfer at seal faces
- Robust design prevents seal face distortion at high pressure insuring a stable lubricating film
- Safe and low leakage behavior in high speed and pressure applications
